# NATIONAL TRANSPORTATION SAFETY BOARD

## AIRCRAFT ACCIDENT REPORT

PROVINCETOWN-BOSTON AIRLINES  
FLIGHT 1039  
EMBRAER BANDEIRANTE, EMB-110P1, N96PB  
JACKSONVILLE, FLORIDA  
DECEMBER 6, 1984

NTSB/AAR-86/04

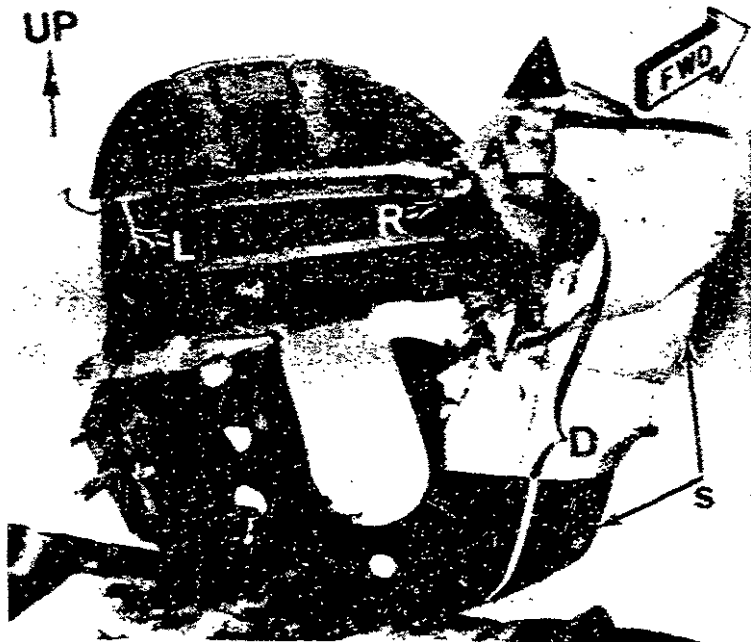
The forward attachment fitting of the horizontal stabilizer on N96PB failed at bulkhead No. 33 when the male lugs of the attachment fitting fractured first in shear and then in tensile overstress (See figures 2A, 2B, 3A, 3B, and 4.) The separated male lugs remained bolted to the clevises on the stabilizer. The tail cone, including bulkhead No. 36, and the ventral fin also separated with the stabilizer. The stabilizer rear attachment structure was deformed, but it continued to connect the stabilizer rear spar and the fuselage bulkhead No. 36 fittings.

The stabilizer forward attachment fitting on the aft side of bulkhead No. 33 was deformed with the upper right corner pulled aft and down, tearing the bulkhead web and separating the structural attachments on the forward side of the bulkhead. The left side of the forward attachment fitting remained flushed and attached to the structure forward of the bulkhead, with many fasteners still intact. The deformation indicates that the male lugs on the attachment fitting fractured from overstress forces as the horizontal stabilizer moved aft and twisted clockwise (looking forward) relative to the fuselage.

Figure 2A.—View of bulkhead No. 33, looking forward.  
L & R show separation of male clevis ears  
from horizontal stabilizer forward attachment fitting

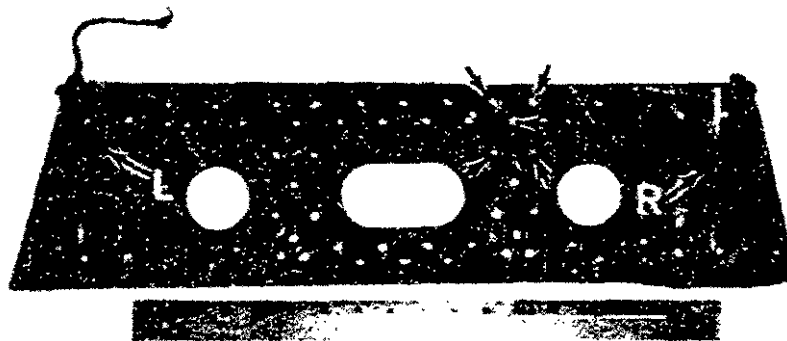
The examination of the bulkhead No. 33 structure disclosed fretting around some rivet holes in channels which transmit the loads from the upper right corner of the forward attachment fitting into the fuselage structure forward of the bulkhead. The bulkhead web break contained a small preexisting fatigue crack, 5/16 inch long.

Figure 2B.—Forward attachment fitting removed from bulkhead No. 33.

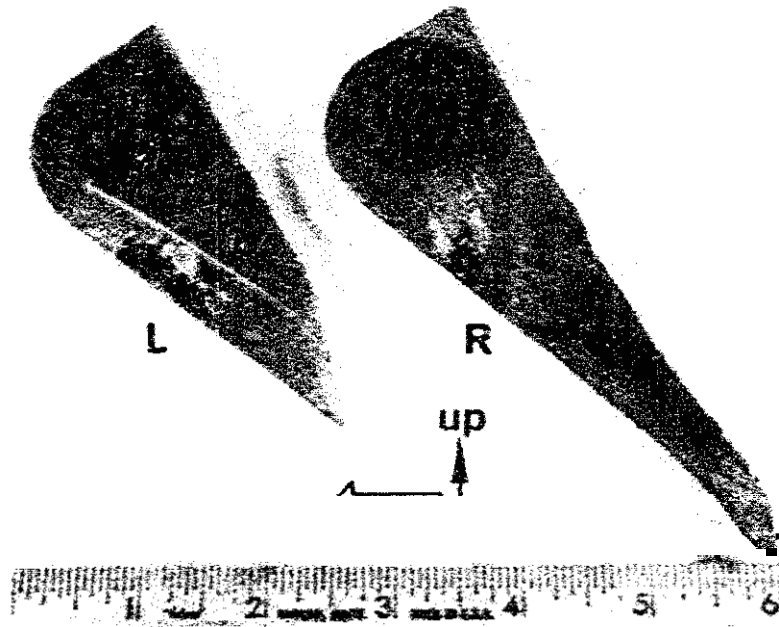
Figure 3A.—Left and right ears of forward attachment fitting which remained attached to horizontal *stabilizer*.

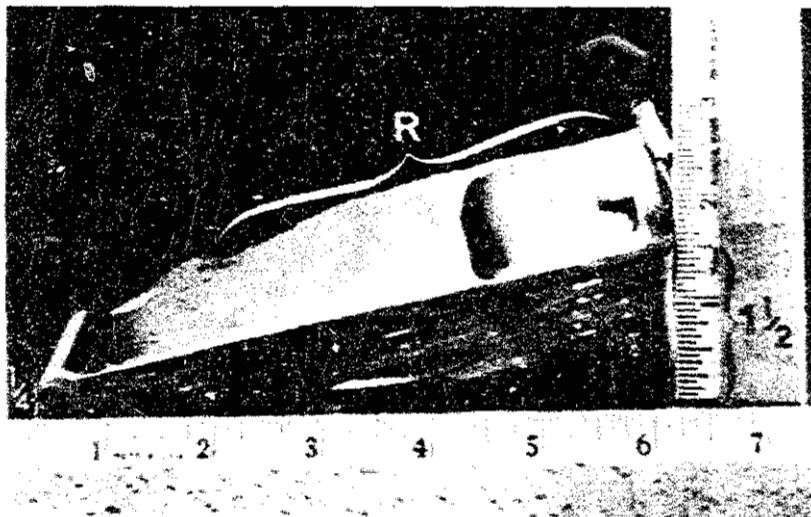
Figure 3B.—View from right side showing twist in forward attachment fitting.

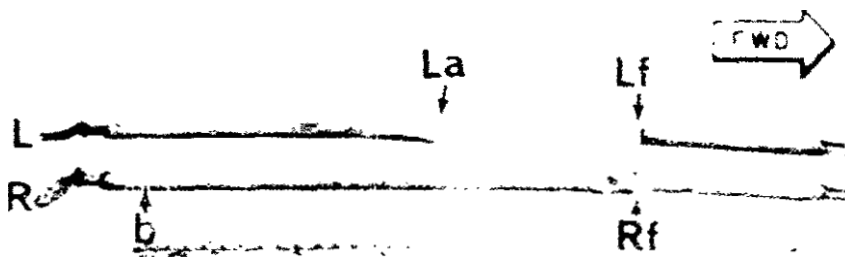
When the horizontal stabilizer or N96PB separated from the fuselage, both the left and right elevator control rods were deformed and had separated in line with bulkhead No. 34 (11 inches aft of the aft bellcranks.) (See figures 6A and 6B.) The forward portion of each rod remained attached to its respective fuselage mounted bellcrank. The remaining 32 1/2 inches of the aft portion of the right elevator control rod remained attached to the right elevator actuating arm after the separation. However, only 21 1/2 inches of the left elevator control rod was still attached to the left elevator actuating arm. The left elevator control rod was fractured in two places; the aft fracture which occurred near the midpoint of the rod, was a compression buckling failure. The 9-inch section of the left control rod between the two fractures was not recovered. There was an impact mark on the aft side of an upper channel at fuselage bulkhead No 35 which matched the shape of the fracture surface on the aft portion of the left control rod. (See figures 6A and 6B.)

Figure 6A.—Left and right elevator control rods showing symmetrical fractures 11 inches aft of aft bellcranks. Note missing sections of left elevator control rod.

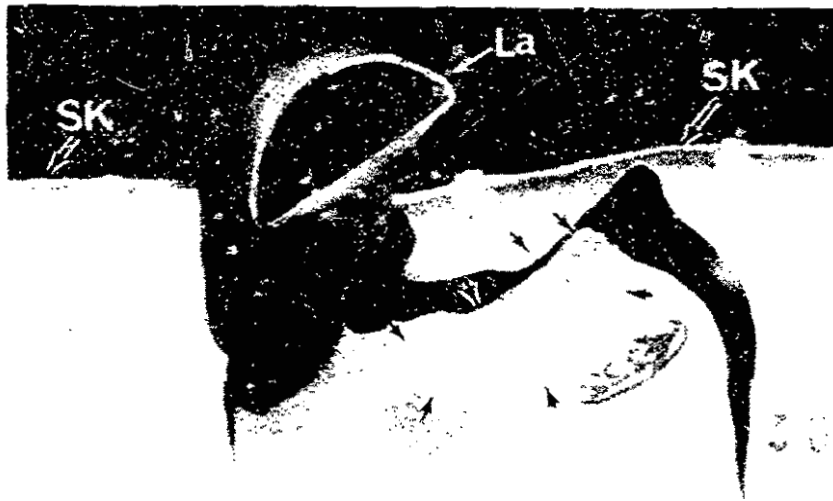
Figure 6B.—View of fracture on aft portion of left elevator control rod and matching impact mark on aft side of upper channel at bulkhead No. 35.

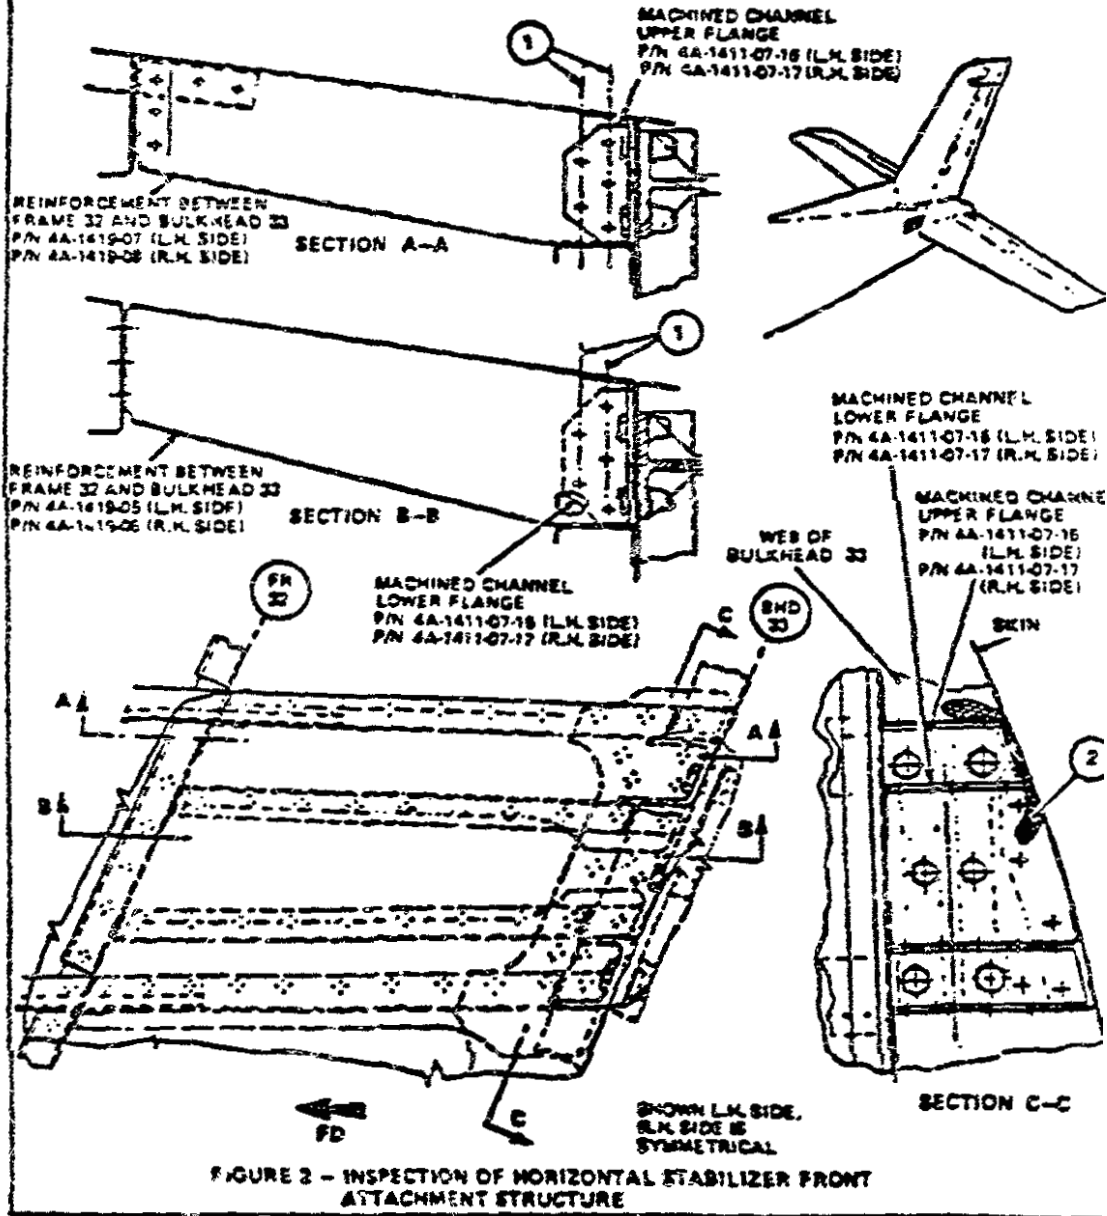
- ① Check this rivet row for loose rivets.
- ② Inspect hatched area for cracks.
